What is a ¹⁴C profile of a mortar?

- 1 Department of Geology and Mineralogy
Åbo Akademi University, Finland
- 2 Department of Art History
Åbo Akademi University, Finland
- 3 Centre for AMS ¹⁴C Dating
University of Aarhus, Denmark
- 4 NSF-Arizona AMS Laboratory
University of Arizona, USA
- 5 Research Laboratory for Archaeology and the History of Art, University of Oxford, UK

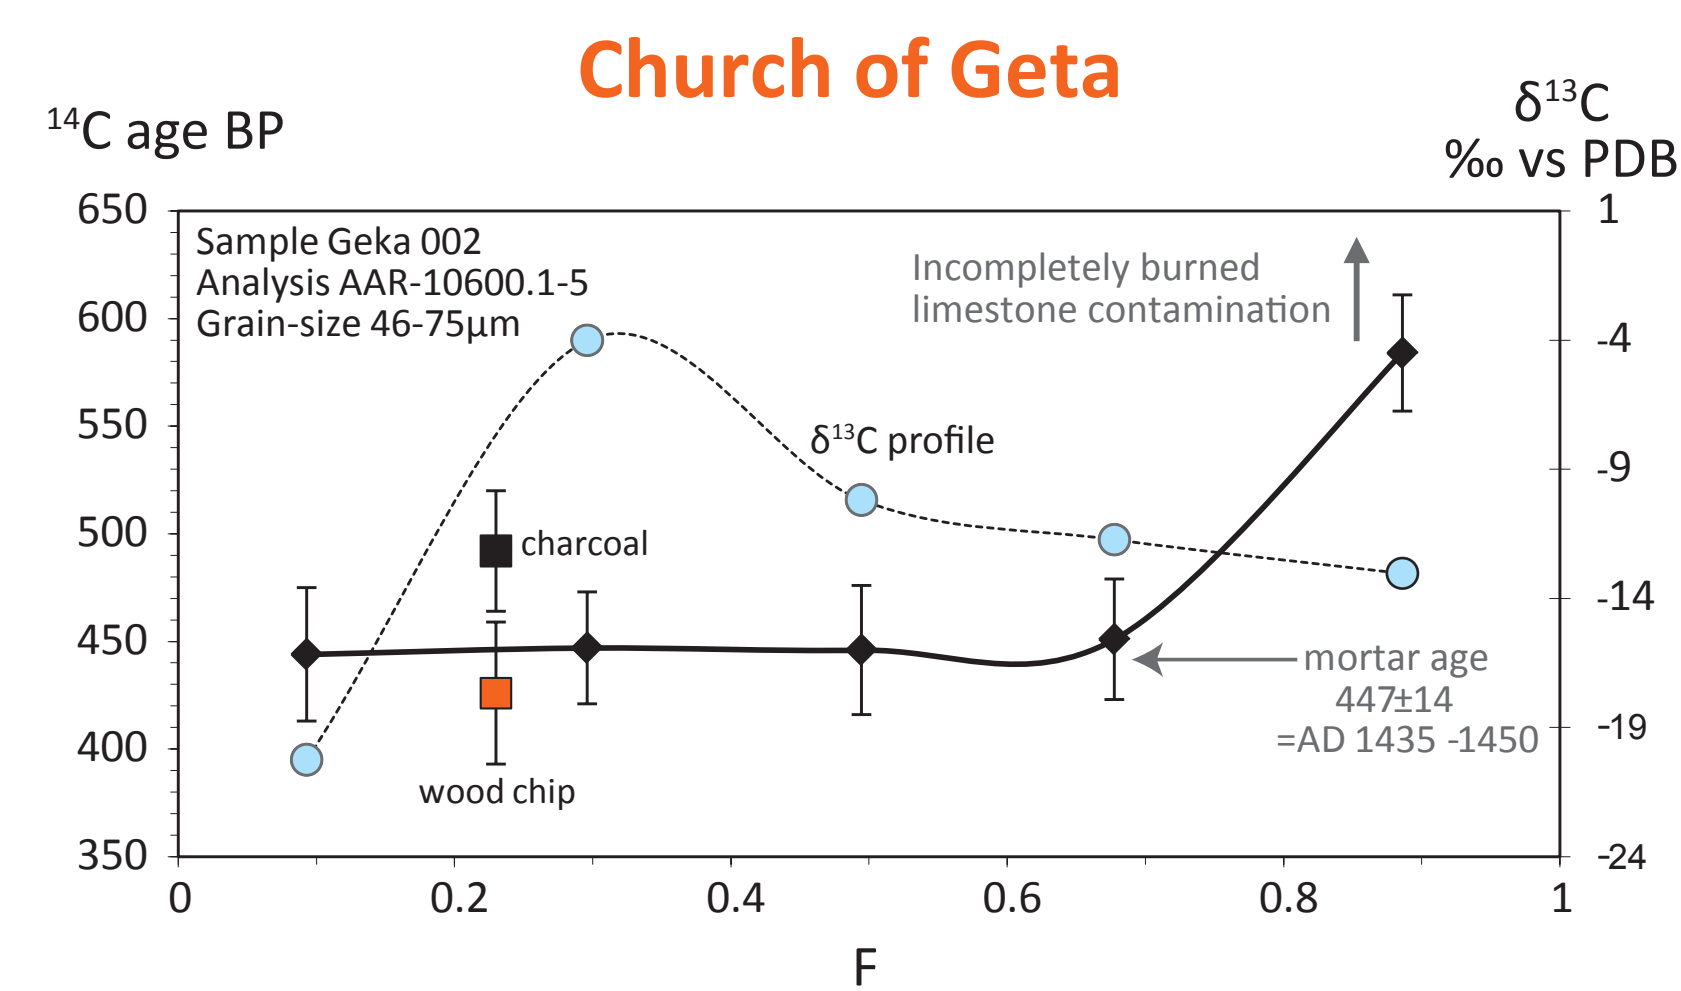
Figure 2. A reliable mortar dating profile with age control from enclosed wood chip and charcoal.

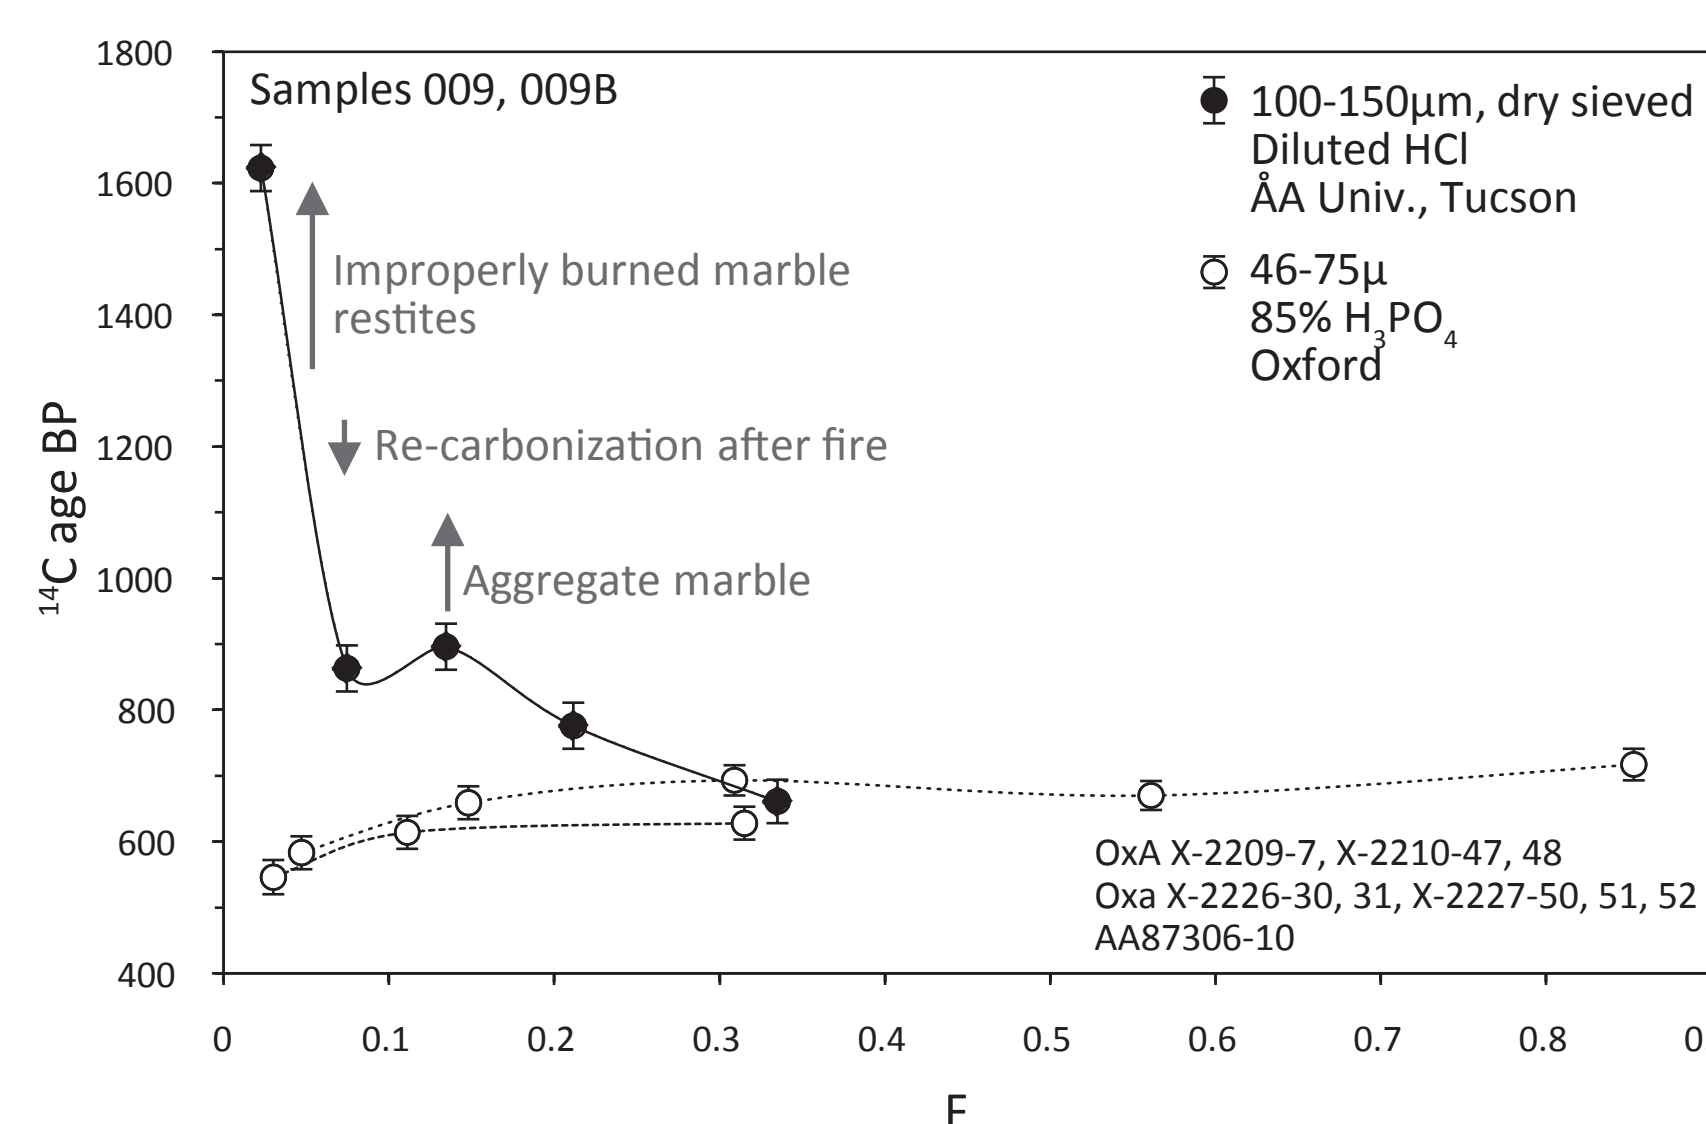
Figure 8. ¹⁴C profiles produced by using H₃PO₄ and diluted HCl hydrolysis. The profiles converge at the correct ¹⁴C age around 30-40% dissolution. A) Turku Cathedral. B) The church of Kökar, Åland Islands (no documented fire).

Yes, we think so. In our preliminary experiments we have results indicating that diluted HCl dissolves most contaminants before the binder carbonate is exhausted.
